TEMECULA CREEK CHANNEL AD 159

REPORT AREA I: LIST OF ALL HABITAT CREATION, RESTORATION, ENHANCEMENT, AND CONSERVATION PROJECT AREAS CURRENTLY BEING MANAGED BY PERMITTEE

REPORT AREA II: DESCRIPTION OF THE HABITAT RESTORATION, ENHANCEMENT, AND CONSERVATION ACTIVITIES PERFORMED WITHIN EACH PROJECT AREA

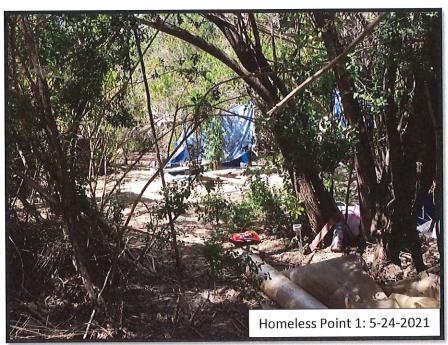
Homeless Point 1: -33.47315° -117.12879°

Monday 5-24-2021: A SAWA Lead Technician inspected Temecula Creek AD 159. Two transients were detected in the same camp near Pechanga Pkwy. (see Homeless Point 1).

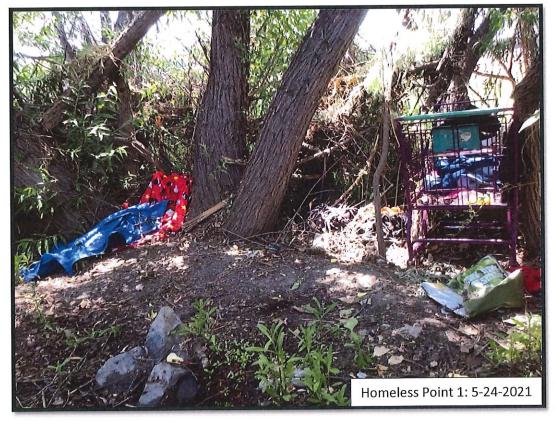
Homeless Point 1: -33.53420 -117.15238°

<u>Wednesday 5-12-2021</u>: A SAWA Lead Technician inspected Santa Gertrudis Creek. One transient still active across from Chaparral High School (see homeless point 1).

<u>Monday 5-24-2021</u>: A SAWA Lead Technician inspected Santa Gertrudis Creek. One transient still active across from Chaparral High School (see homeless point 1).
