## **TEAMRCD CUMULATIVE REPORT: 1-1-15 THROUGH 12-31-18**

**ABOUT THE DISTRICT:** The Temecula-Elsinore-Anza-Murrieta Resource Conservation District (TEAM RCD) provides conservation, enhancement, education and outreach services within a boundary covering 505,000-A or approximately 798 square miles of Riverside County, extending south from Scott Road to the San Diego County line; from east of Anza and west to the Orange County line, in addition to a loop around Lake Elsinore. The District is governed by a five-member Board of Directors appointed by the Riverside County Board of Supervisors, and assisted in mission-focused project work by an evolving team of non-voting Associate Directors. Board members meet monthly in Temecula to discuss and take action on District business, both individually and on cooperation with core partners including the Natural Resources Conservation Service (NRCS), Riverside County Flood Control and Water Conservation District (RCFCWCD), Rancho California Water District (RCWD) and Mission Resource Conservation District (Mission RCD), among others.

**TEAM RCD REPORTING:** TEAM RCD received its Streambed Alteration Agreement from the California Department of

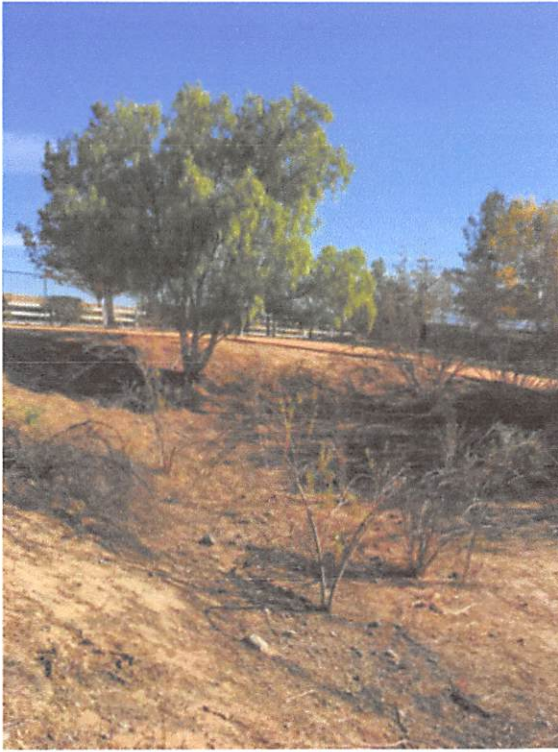
- Native plant die-off (*Baccharis salicifolia*; *Salix* sp.) at east end of easement near Washington Street (Photo Point AF1).
- Non-native plant species observed in the easement area: *Tamarix ramosissima*, *Cortaderia selloana*, *Eucalyptus* sp, and *schinus molle*.
- A new culvert has been created at Photo Point AF3 and mulefat has been recently planted in the area. Machinery used in the new plantings left tracks in the easement
- Debris (brush) pile-up and old irrigation boxes, most likely left by landscapers
- Patchy vegetation documented throughout the easement

Representative 2017 photos: (L) AF1/mulefat resprouting; (R) Sparse CE Vegetation

Actions taken: documentation of recommended actions including removal of documented invasive species and removal of site trash were included in the 2017 report covering annual work at Adeline Farms.

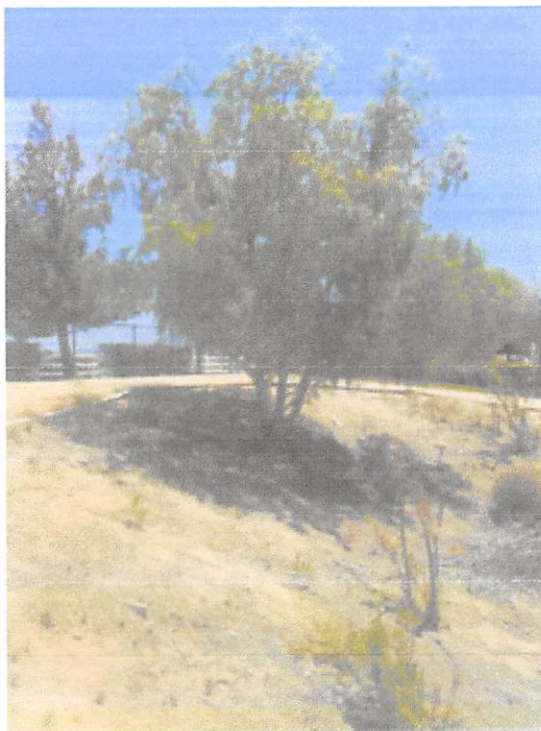
- Multiple dead cottonwood trees (*Populus fremontii*), photo AF2
- Non-native species observed, including *tamarix ramosissima*, *Cortaderia selloana*, *Eucalyptus* spp, *Centaurea solstitialis*, *Schinus molle*
- Debris and old irrigation boxes observed on site; furniture observed on site
- Patchy vegetation

Representative 2018 Photos: (L) mulefat die-off; (R) non PP Photo showing dumped trash

Actions taken: documentation of recommended actions including removal of documented invasive species and removal of site trash were included in the 2018 report covering annual work at Adeline Farms.

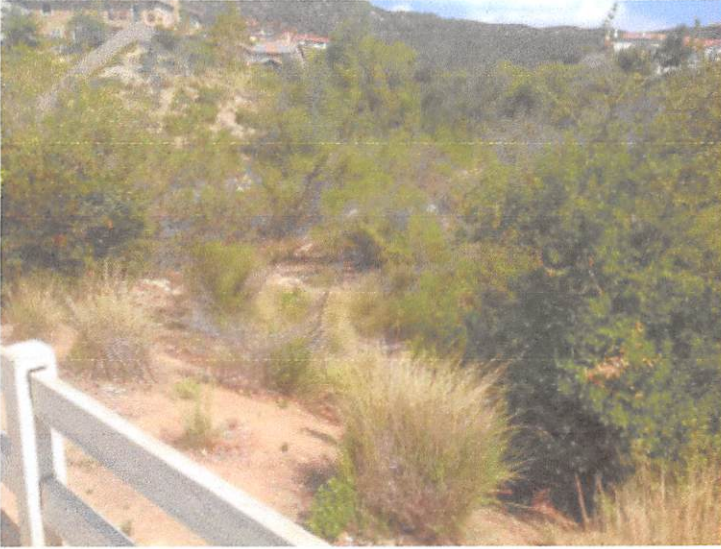
**2015 Photos:** (L) Pumpkin Street riparian scrub; (R) Vegetation die-off at Crabapple Street

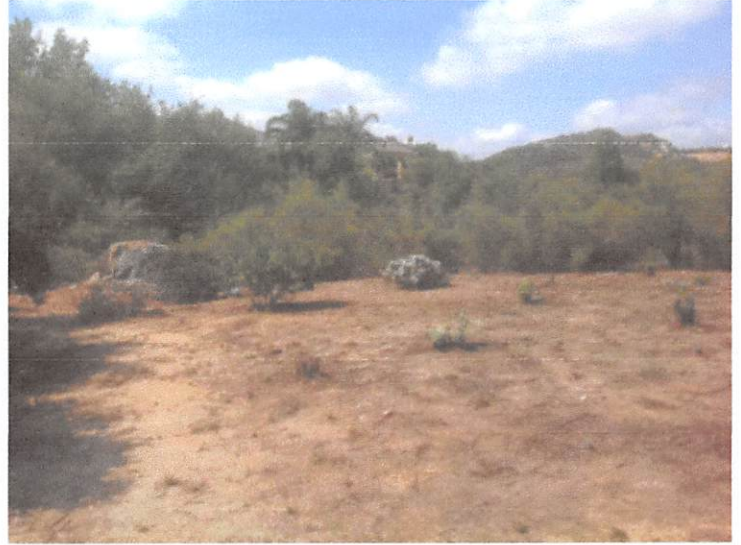
- Ms. Long and Dr. Hopkins recorded the weather as 93 degrees, clear skies, and light wind.
- The report also indicates that no alteration of the easement area was observed during the site, although there was trash indicated in the work area off of the Crabapple section of the easement

- Greer Ranch HOA was informed of the need to keep easement areas free of trash when work is occurring within the Ranch property
- Dr. Hopkins also indicated need to follow up with the HOA on off-road activity at the end of Orchid Tree Land, following a conversation with the HOA indicated to have occurred in July of 2014.

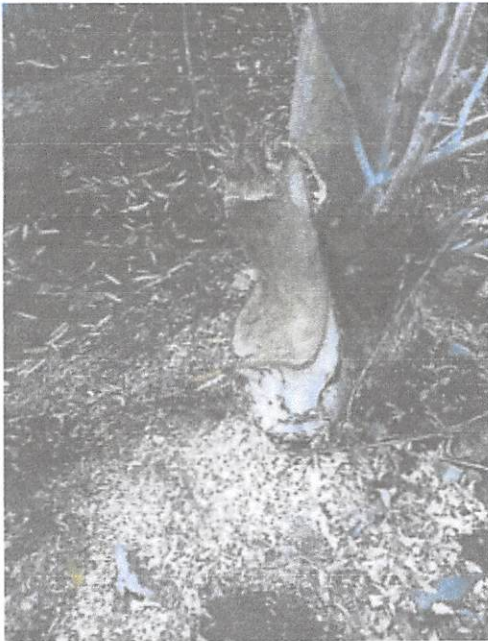
- Lack of CE indicator signs
  - One beaver (*Castor canadensis*) was spotted and associated damage to nearby tree was photo documented
- **Crabapple Street to Pumpkin Street:**

**2016 Photos:** (L): tree damage from beaver; (R) *Tamarix spp.* visible at Evandel Rd/Iceplant Lane

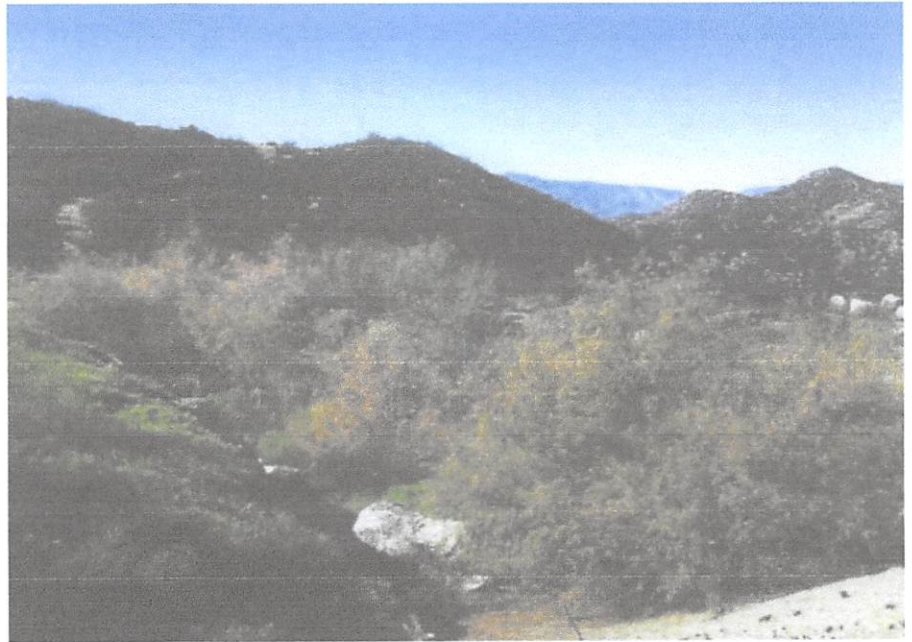
- **Evandel Rd (Near Iceplant Way)**
  - Non-native species observed (*Tamarix spp.*)
- **Greer Road (from Pabesu Rd to Nutmeg Street)**
  - Non-natives observed in easement area, including *Nicotiana glauca*; *Tamarix ramosissima*; *Schinus molle*

- SAWA recommended installation of CE signs and removal of invasives to the extent that funding is available, recognizing that these are not required actions within the easement terms and therefor may not be funded.

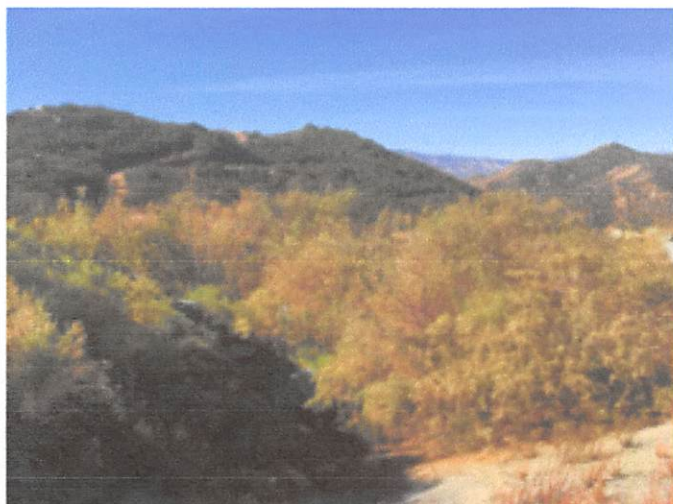
- Non-native plant species observed in the easement area: Tamarisk.
- **Evangel Road (by Iceplant Lane):**
  - Non-native plant species observed in the easement area: Tamarisk

**2017 Representative Photos:** (L) *Tamarix spp.* at Evandel Rd/Iceplant Lane; (R) Greer Rd near Pabesu Rd intersection

- SAWA recommended installation of CE signs and removal of invasives to the extent that funding is available, recognizing that these are not required actions within the easement terms and therefor may not be funded.
- Debris piles, landscaping soils, and other refuse should be removed;
- Culverts should be cleared of debris to allow water to drain downstream.

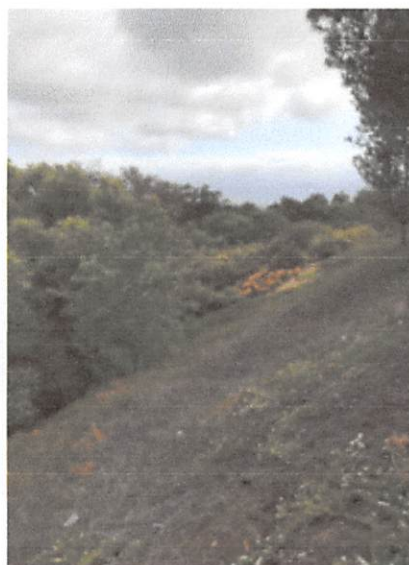
- **Greer Road (from Pabesu Road to Nutmeg Street):**
  - Non-native plant species observed in the easement area: *Schinus molle*; *Tamarix spp*; *Nicotiana glauca*

- Landscaping plants along the slope have begun to encroach into the riparian habitat
  - Blockage of pipes downstream near Nutmeg Street appears to be causing inundation of willows and other native species

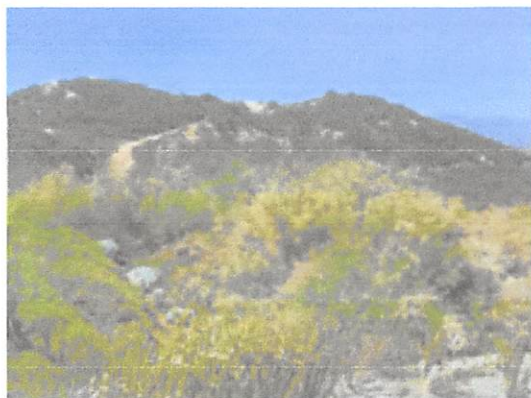
**2018 Representative Photos:** (L) *Tamarix spp.* at Evandel Rd/Iceplant Lane; (R) Greer Rd near Pabesu Rd intersection

- SAWA recommended installation of CE signs and removal of invasives to the extent that funding is available, recognizing that these are not required actions within the easement terms and therefore may not be funded.
- Debris piles, landscaping soils, and other refuse should be removed;
- Culverts should be cleared of debris to allow water to drain downstream.
- Dead oaks should be assessed/evaluated

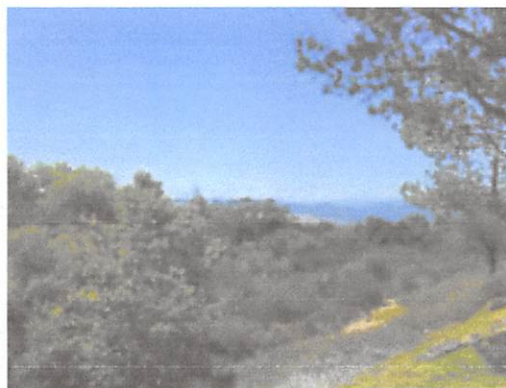
- Non-native plant species observed in the easement area: *Tamarix spp*; *Nicotiana glauca*; *Schinus molle*
  - Landscaping plants along the slope have begun to encroach into the riparian habitat

- Oak trees dying within the CE
