# ACTION ITEMS / DISCUSSION CALENDAR

## CDFW REPORTS: TEAM RCD – RIV FLOOD TRANSIENT MONITORING

# **Greer Ranch**

## **2020 Annual Monitoring Report**

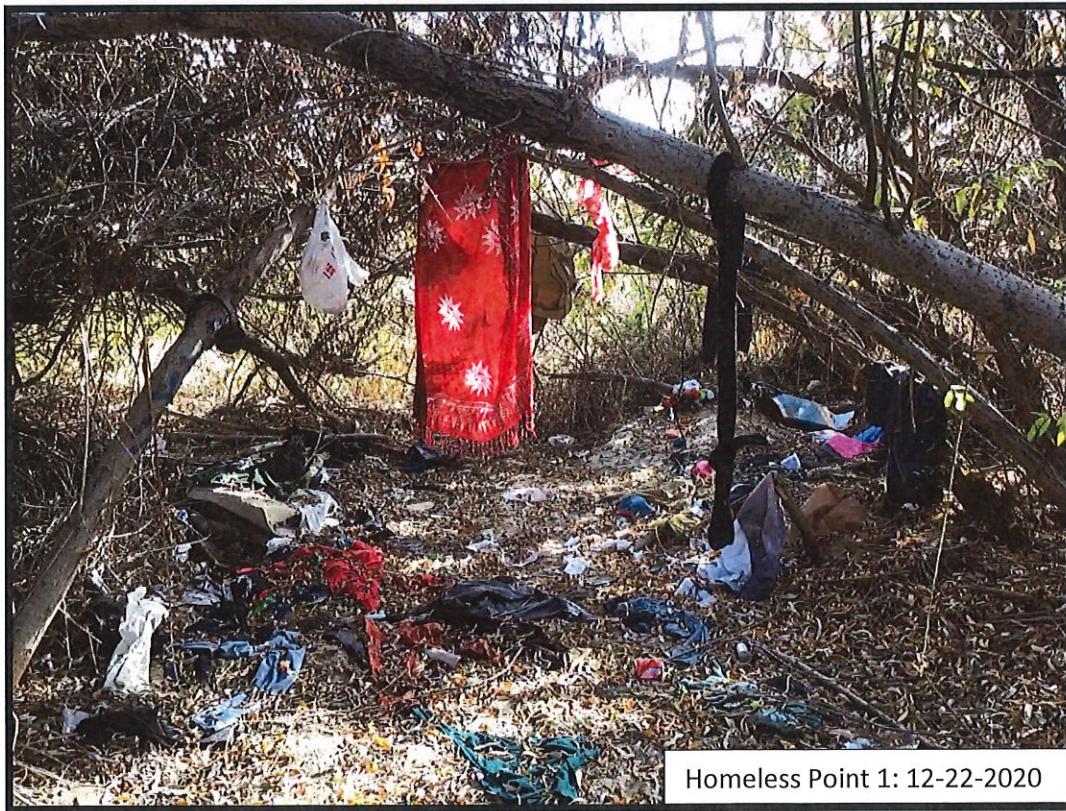
Homeless Point 1: 12-22-2020

Wednesday 12-9-2020: A SAWA Lead Technician inspected Santa Gertrudis Channel. One camp still active near Chaparral High School. (See homeless point 1).

Tuesday 12-22-2020: A SAWA Lead Technician inspected Santa Gertrudis Channel. One camp still active near Chaparral High School. (See homeless point 1).

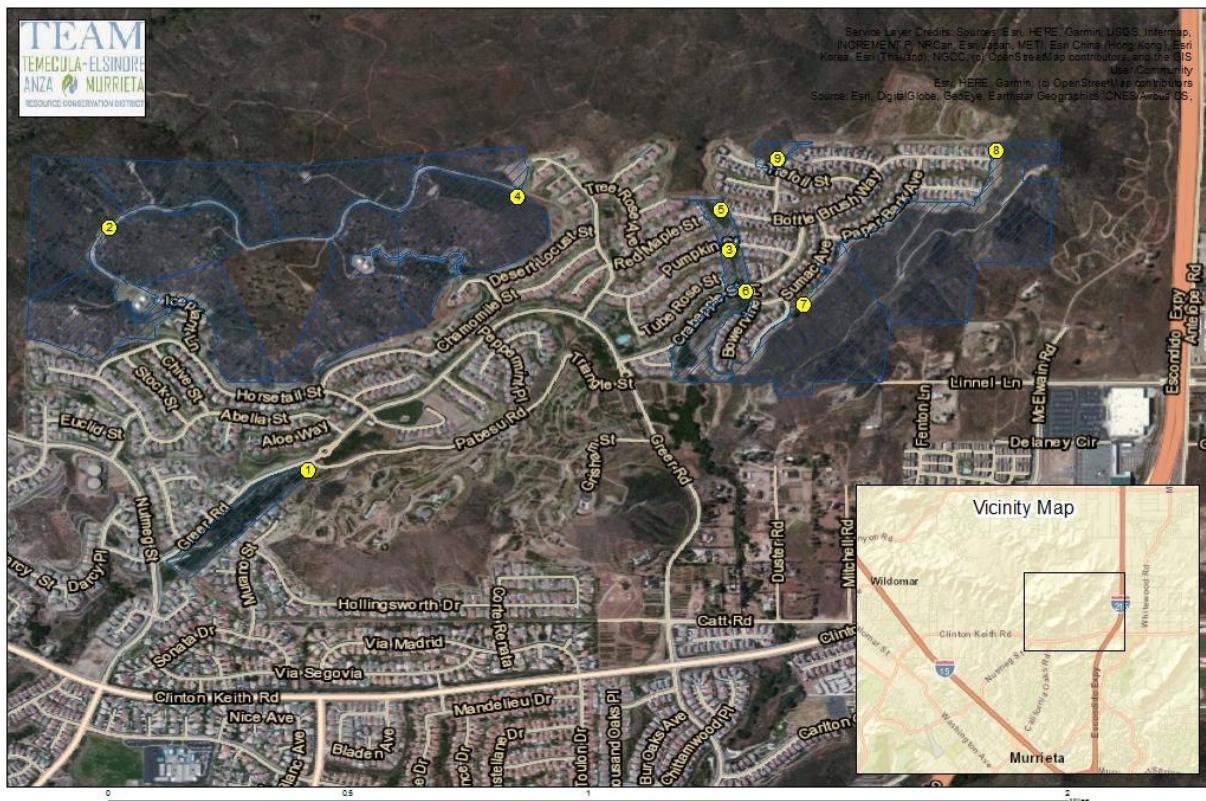
## PHOTO POINTS (PP) Map

Photo Point #	Direction	Coordinates (Lat, Lon)
1	50°	(33.60244°, -117.19772°)
2	60°	(33.60973°, -117.20375°)
3	130°	(33.60908°, -117.18504°)
4	120°	(33.61069°, -117.19140°)
5	150°	(33.61028°, -117.18527°)
6	200°	(33.60783°, -117.18452°)
7	50°	(33.601742°, -117.18276°)
8	145°	(33.61206°, -117.17697°)
9	290°	(33.61182°, -117.18356°)

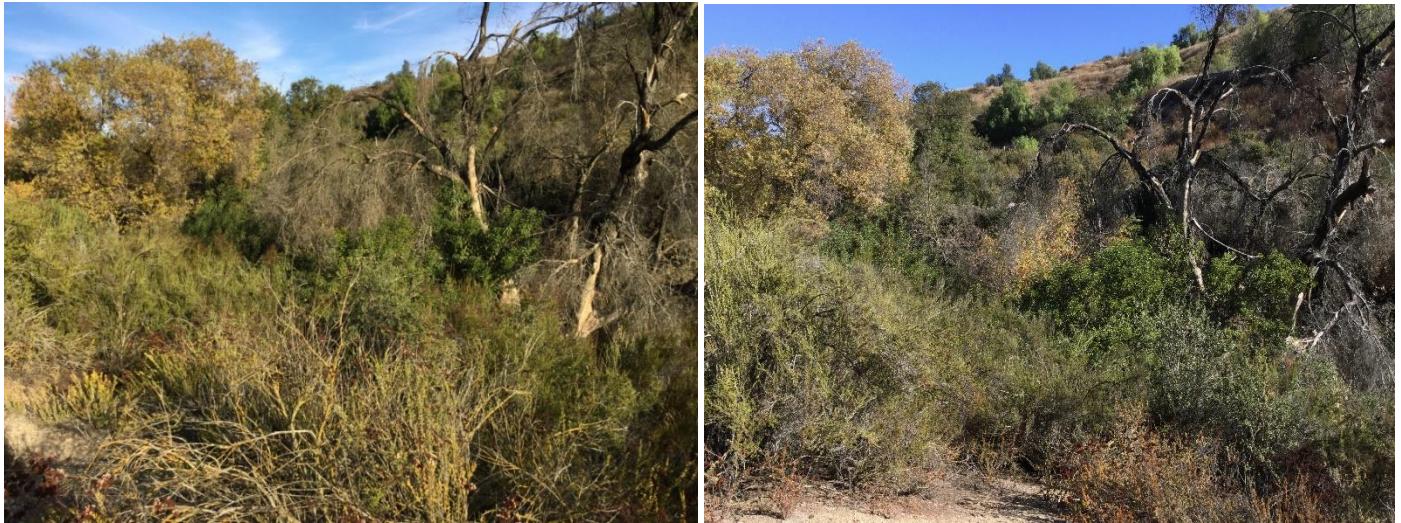
**Photo Point 1:** Photos taken on 12/17/19 (left) and on 12/24/20 (right)

**Summary of Conditions:** This Photo Point shows an area dominated by healthy California sycamore woodland. Sycamore trees (*Platanus occidentalis*) make up the majority of the canopy in addition to cottonwood trees (*Populus fremontii*). Ground cover is composed of California buckwheat (*Eriogonum fasciculatum*) and chamise (*Adenostoma fasciculatum*). Tumbleweed (*Salsola tragus*) sprouts were observed infrequently between shrubs. No other invasive plants were noted in this parcel. A standing dead sycamore damaged in previous fir can be observed in this photo point, providing possible nesting/hunting opportunities for dependent wildlife.

**Recommended Action:** No immediate removal needs identified in this Photo Point.

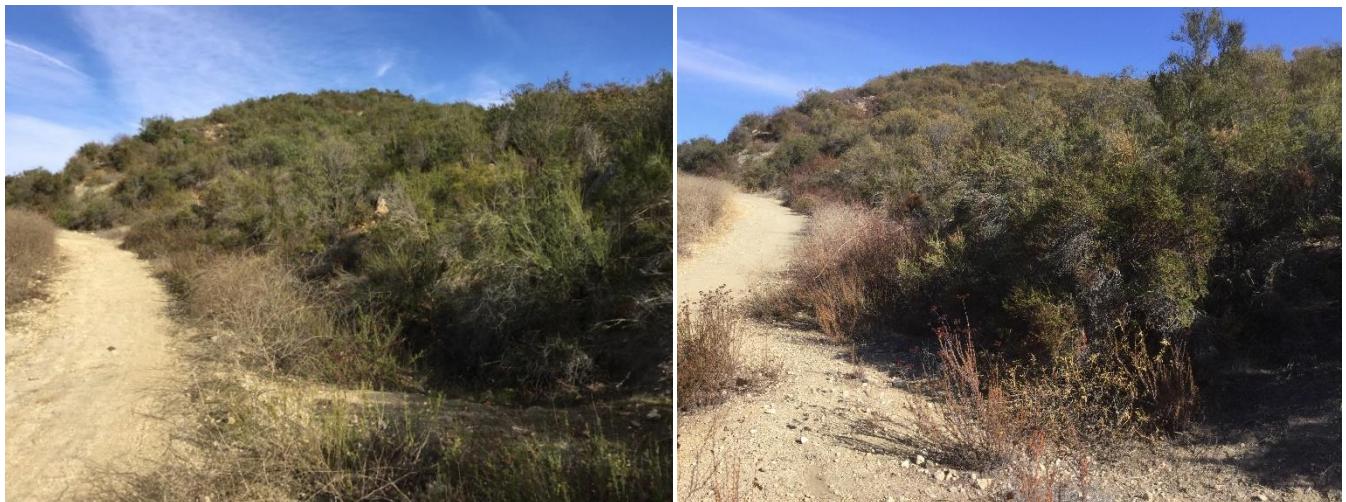
**Photo Point 2:** Photos taken on 12/17/19 (left) and on 12/24/20 (right)

**Summary of Conditions:** This Photo Point shows a largely functional chamise chaparral habitat. The dominate vegetation observed throughout this parcel included (tall shrub) scrub oak (*Quercus*

*berberidifolia*), in addition to short shrubs chamise (*Adenostoma fasciculatum*) and California buckwheat (*Eriogonum fasciculatum*). Scattered manzanita (*Arctostaphylos*) were also observed at this point. Invasive short-pod mustard (*Hirschfeldia incana*) growth for last season was observed on the sides of the service road that surround the easement. Within the easement, invasive brome (*Hordium sp.*) and stork's bill filaree (*Erodium cicutarium*) were both identified.

**Recommended Action:** Treatment of annual invasives identified within this Photo Point location should be completed prior to 2021 monitoring.

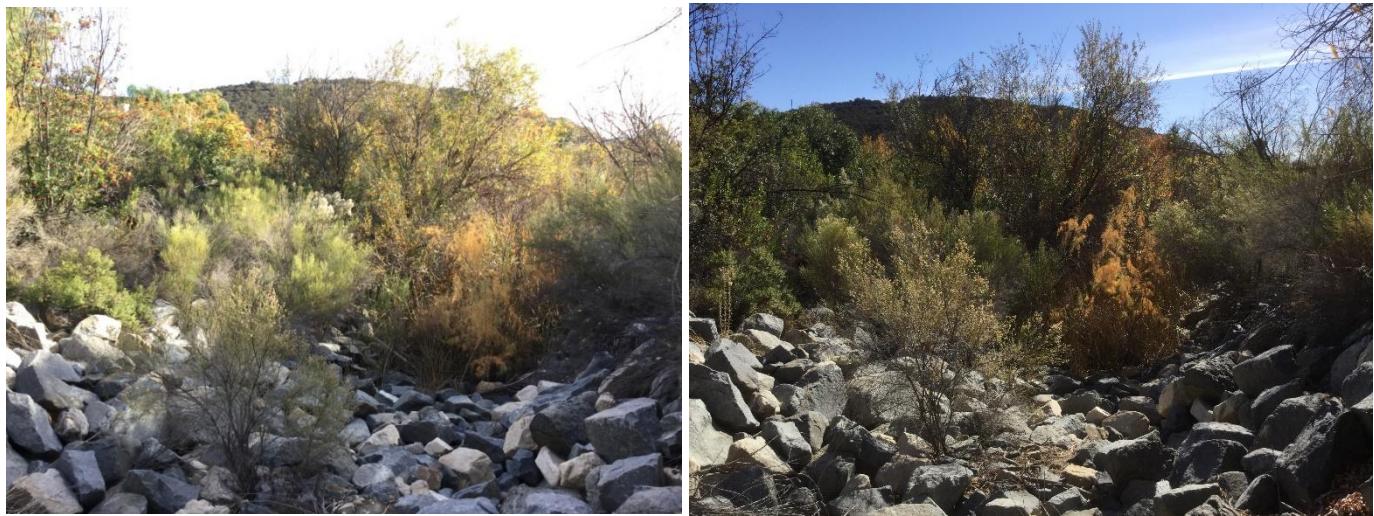
**Photo Point 3:** Photos taken on 12/17/19 (left) and on 12/24/20 (right)

**Summary of Conditions:** This Photo Point represents a mixed-canopy habitat consisting of native sycamore (*Platanus occidentalis*), manzanita (*Arctostaphylos sp.*), and red willow (*Salix laevigata*) for woody coverage. Coyote bush (*Baccharis pilularis*) made up the majority of shrubs observed. Invasive salt cedar (*Tamarix ramosissima*) was observed in the center channel (in photo).

**Recommended Action:** treatment of tamarisk (*Tamarix ramosissima*) should be done in the first quarter of 2021 to prevent further regrowth/seed production.

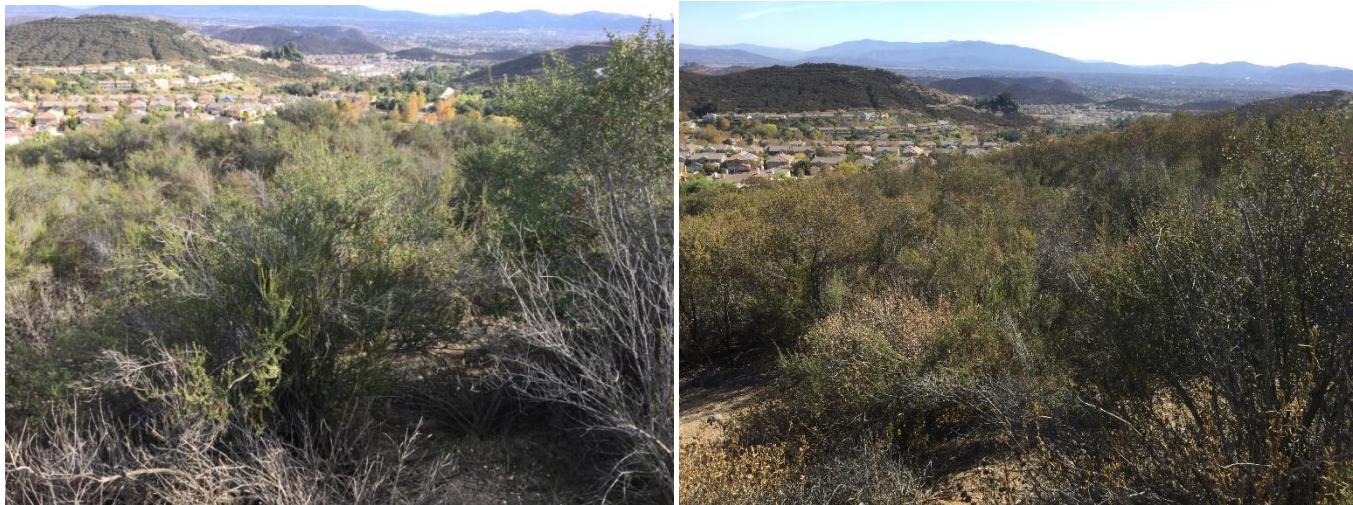
**Photo Point 4:** Photos taken on 12/17/19 (left) and on 12/24/20 (right)

**Summary of Conditions:** This Photo Point includes a chamise chaparral alliance. The dominate plant is chamise (*Adenostoma fasciculatum*) with the co-dominant species being scrub oak (*Quercus berberidifolia*). California buckwheat (*Eriogonum fasciculatum*) was also found in throughout this area. All of these native plants are also actively recruiting with observable sprouts found throughout the easement; however, open areas between shrubs contain invasive annuals including short-pod mustard (*Hirschfeldia incana*), stork's bill filaree (*Erodium cicutarium*), and brome (*Bromus sp.*).

**Recommended Action:** Treatment of invasive annuals should be done in coordination with monitoring or as part of a separate site visit to treat other invasives within this easement.

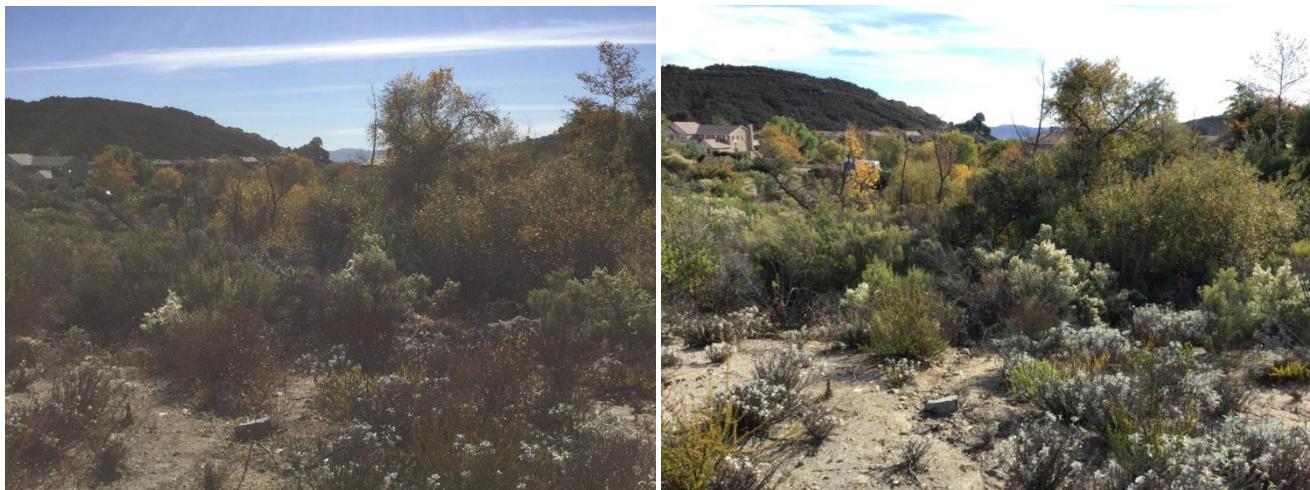
**Photo Point 5:** Photos taken on 12/17/19 (left) and on 12/24/20 (right)

**Summary of Conditions:** This Photo Point includes mixed riparian forest, including sycamore (*Platanus occidentalis*), cottonwoods (*Populus fremontii*), and willows (*Salix sp.*). The understory is composed of a

mix of shrubs and forbs including brittlebush (*Encelia farinosa*) , coyotebush (*Baccharis pilularis*), deerweed (*Acmispon glaber*) , black sage (*Salvia mellifera*) , and telegraphweed (*Heterotheca grandiflora*). A recreation trail was documented through portions of the parcel. Invasive tocalote (*Centaurea melitensis*) and short-pod mustard (*Hirschfeldia incana*) cotyledons were observed on the sides of this recreation trail and near the north end of this Photo Point site.

**Recommended Action:** Treatment of invasive annuals should be done in coordination with monitoring or as part of a separate site visit to treat other invasives within this easement. Invasive material should be mulched and used to obscure the trail if possible.

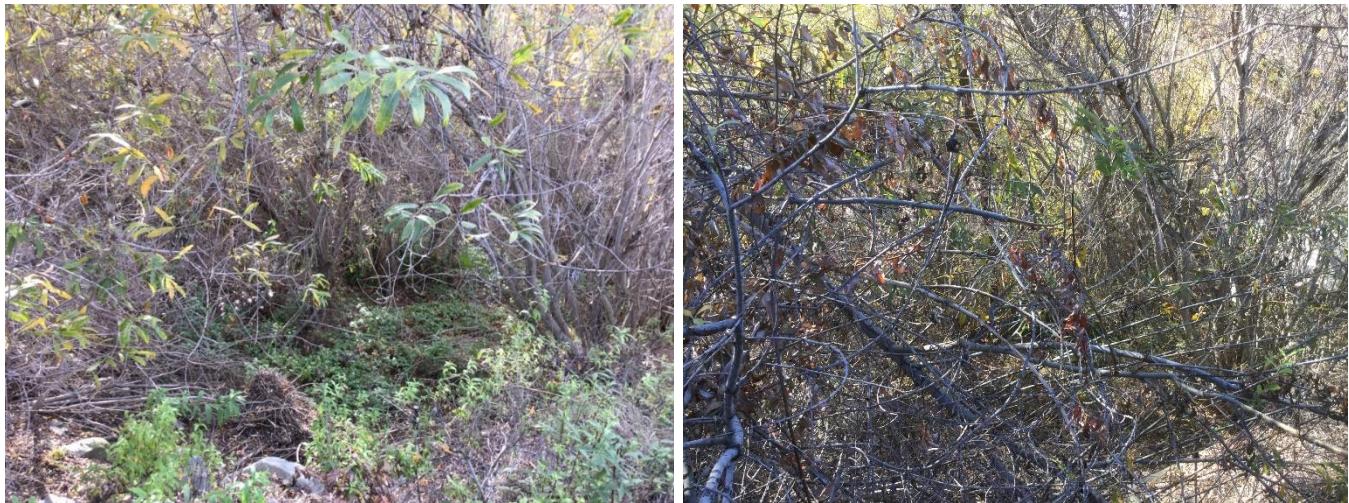
**Photo Point 6:** Photos taken on 12/17/19 (left) and on 12/24/20 (right)

**Summary of Conditions:** This Photo Point consisted mainly of red willow (*Salix laevigata*) and Pacific blackberry (*Rubus ursinus*). An increase in California wild rose (*Rosa californica*) was observed between 2019 and 2020 monitoring. A large Mexican fan palm (*Washingtonia robusta*) observed last year has appeared to decline in health, and a standing dead willow documented in 2019 remains on site.

**Recommended Action:** a survey of the two dead trees should be completed on-site by a qualified biologist prior to removal and proper disposal of biomass of both the palm and willow, due to risk posed to residents using the adjacent area for recreation.

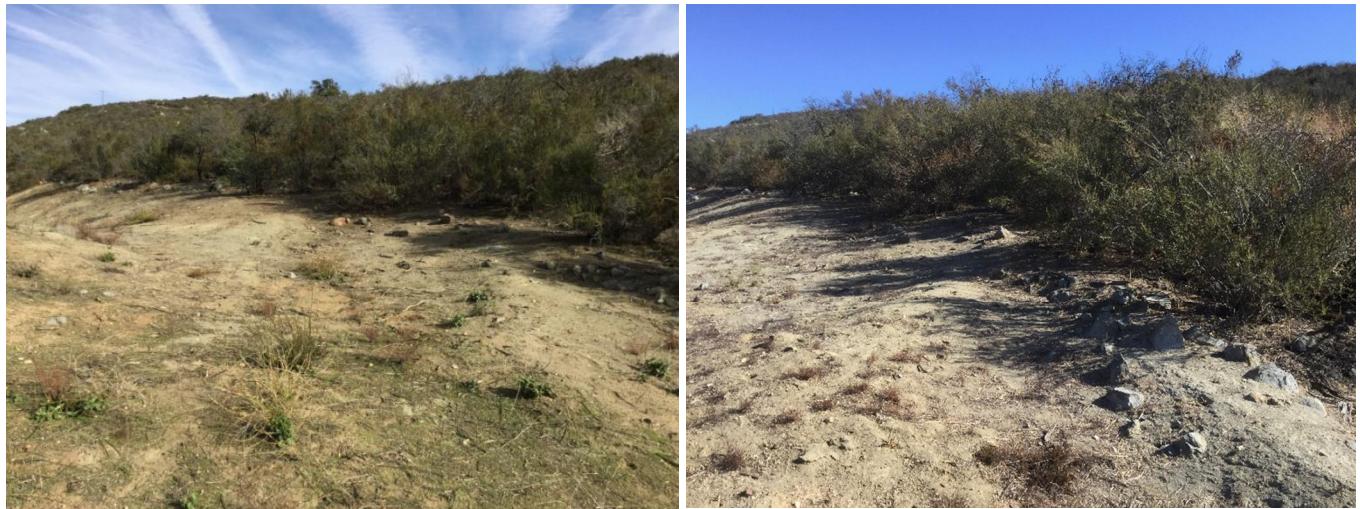
**Photo Point 7:** Photos taken on 12/17/19 (left) and on 12/24/20 (right)

**Summary of Conditions:** Most of this Photo Point is composed of dense chamise (*Adenostoma fasciculatum*), California buckwheat (*Eriogonum fasciculatum*), and scrub oak (*Quercus berberidifolia*). A “buffer” area inside of the easement separates the dense woody shrubs from the residential homes, consisting primarily of California buckwheat. Scattered short-pod mustard (*Hirschfeldia incana*) as well as stork’s bill filaree (*Erodium cicutarium*) and mustard cotyledons were observed germinating.

**Recommended Action:** Treatment of invasive annuals should be done in coordination with monitoring or as part of a separate site visit to treat other invasives within this easement.

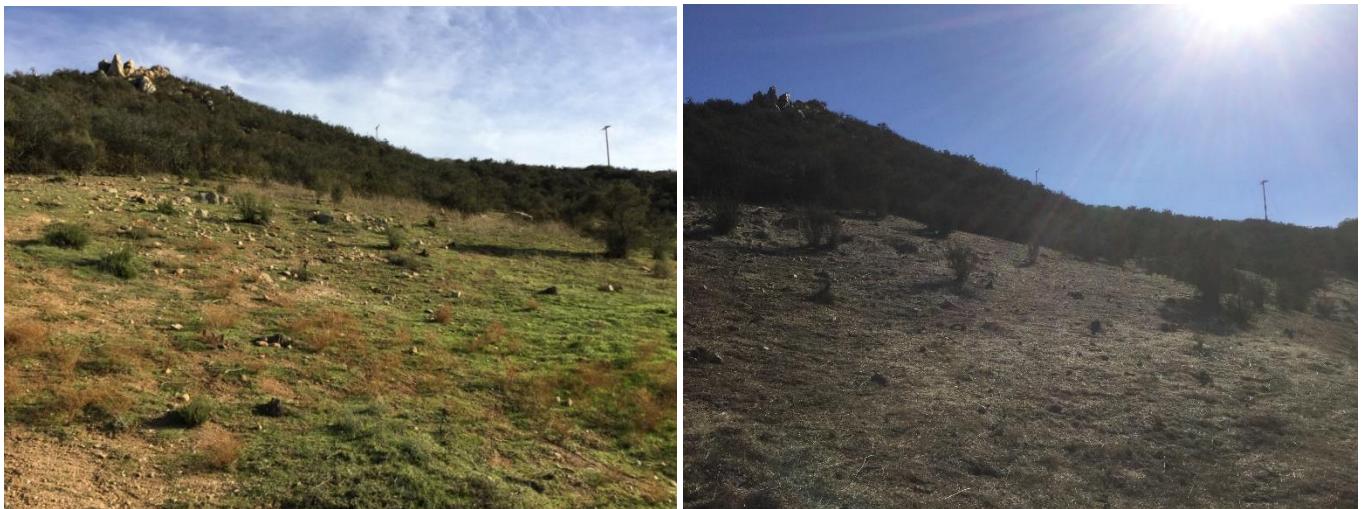
**Photo Point 8:** Photos taken on 12/17/19 (left) and on 12/24/20 (right).

**Summary of Conditions:** Most of this Photo Point consisted of established buckwheat (*Eriogonum fasciculatum*), black sage (*Salvia melifera*), chamise (*Adenostoma fasciculatum*), and scrub oak (*Quercus*

*berberidifolia*). Other species observed included California buckwheat and the rare listed paniculate tarplant [(*Deinandra paniculata*)] California Rare Plant Rating: 4.2], in addition to non-natives consisting of short-pod mustard (*Hirschfeldia incana*) and stork's bill filaree (*Erodium cicutarium*).

**Recommended Action:** Treatment of invasive annuals should be done in coordination with monitoring or as part of a separate site visit to treat other invasives within this easement.

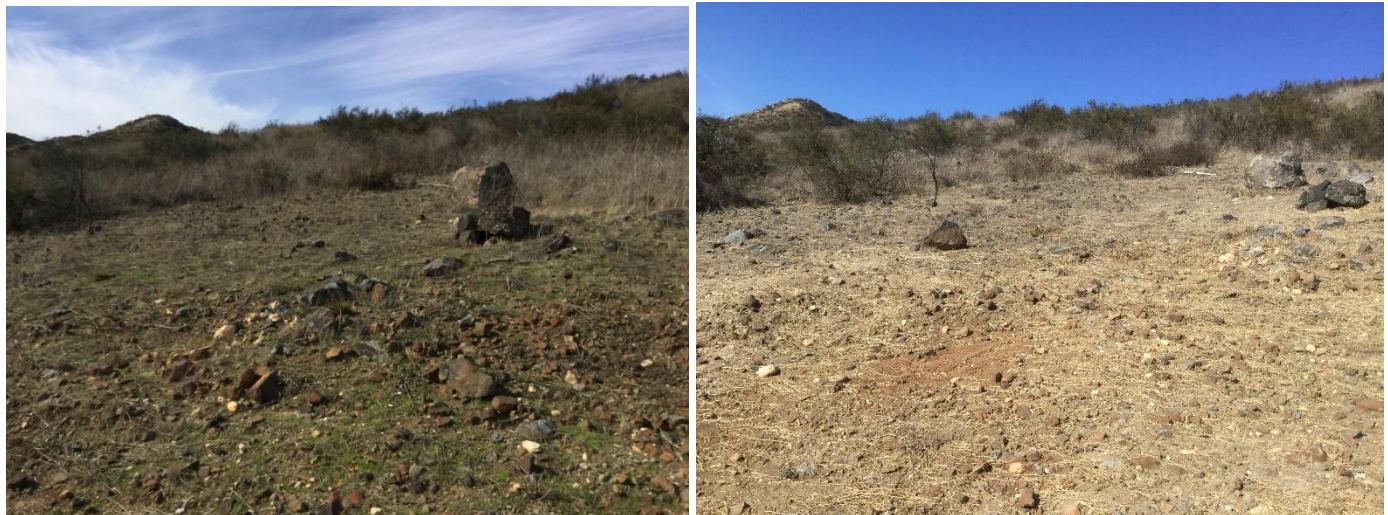
**Photo Point 9:** Photos taken on 12/17/19 (left) band on 12/24/20 (right)

**Summary of Conditions:** Patches of mature California buckwheat (*Eriogonum fasciculatum*), chamise (*Adenostoma fasciculatum*), and black sage (*Salvia apiana*) can be found throughout most of this Photo Point. Areas that do not have mature shrubs establish have become inundated with invasive plants and seed including tumbleweed (*Salsola tragus*) short-pod mustard (*Hirschfeldia incana*), tocalote (*Centaurea melitensis*), short-pod mustard, brome (*Bromus sp.*), and stork's bill filaree (*Erodium cicutarium*).

**Recommended Action:** Treatment of invasive annuals should be done in coordination with monitoring or as part of a separate site visit to treat other invasives within this easement.

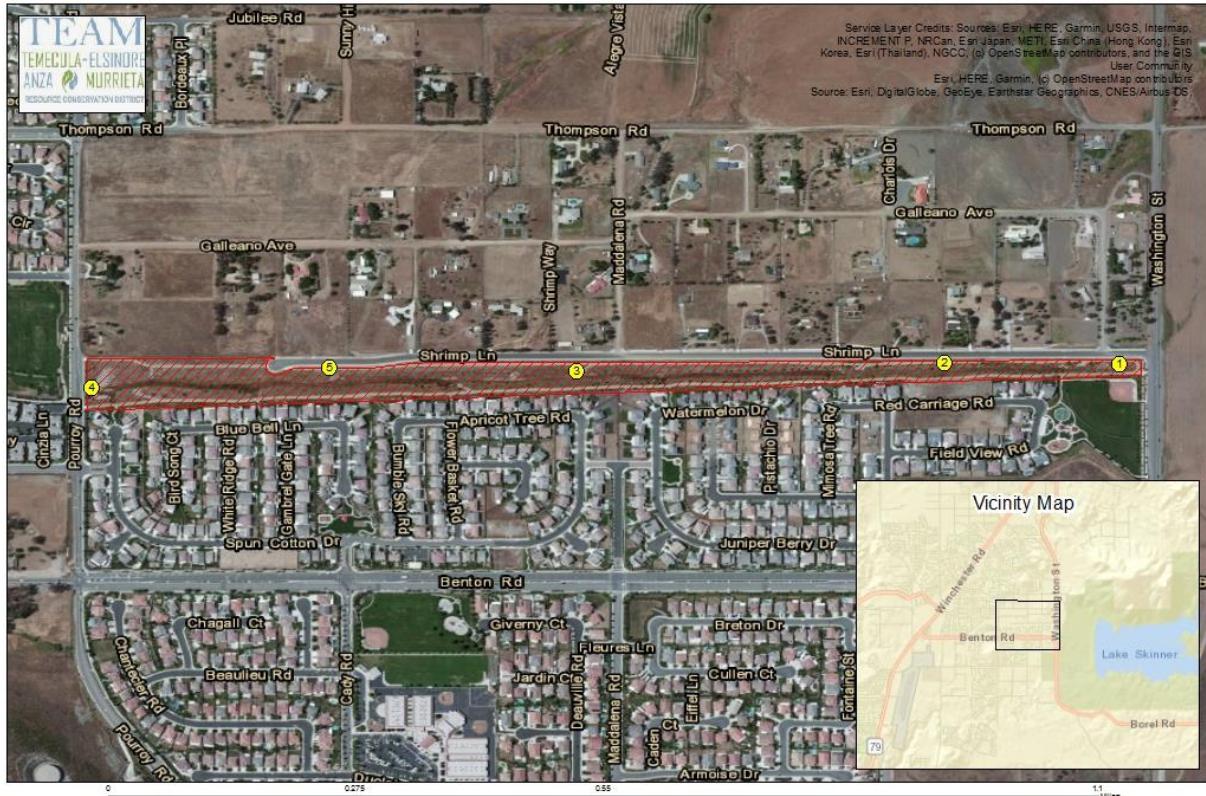
## PHOTO POINTS (PP)

Photo Point #	Direction	Coordinates (Lat, Lon)
1	107°	(33.59439°, -117.08416°)
2	236°	(33.59443, -117.08709°)
3	254°	(33.59430°, -117.09301°)
4	290°	(33.5903°, -117.10081°)
5	141°	(33.59435°, -117.09699°)

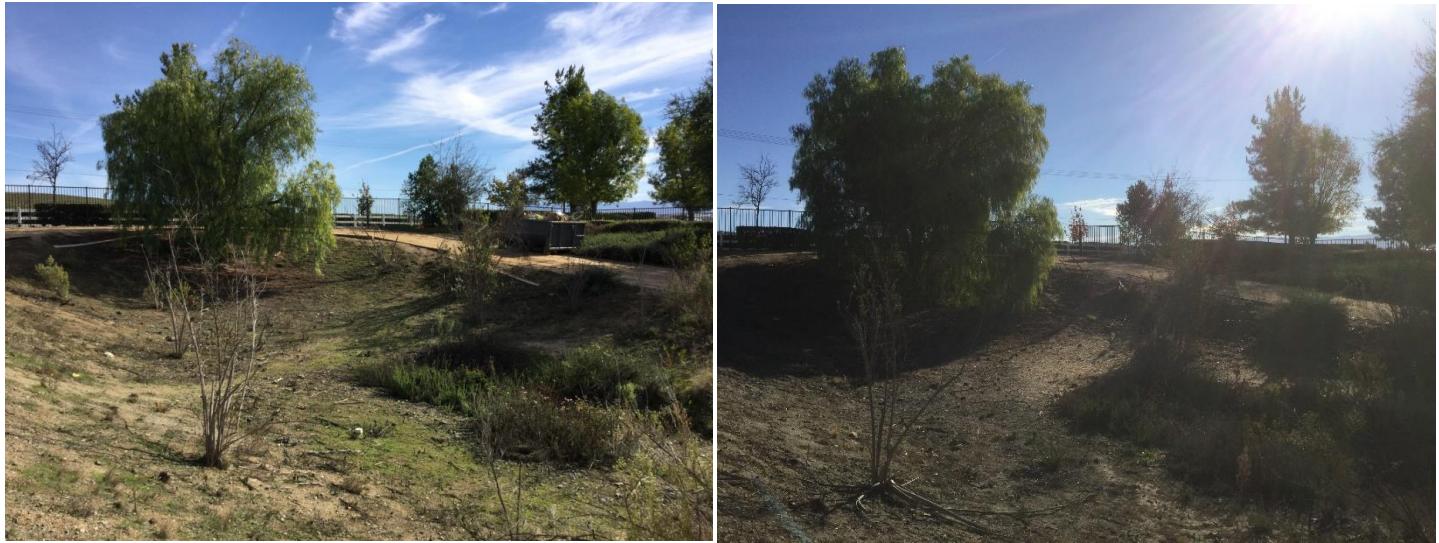
**Photo Point 1:** Photos taken on 12/17/19 (left) and on 12/24/20 (right)

**Summary of Conditions:** This Photo Point is characterized by low-density mulefat (*Baccharis salicifolia*)/California buckwheat (*Eriogonum fasciculatum*) scrub. No additional mulefat was observed in 2020; however, the California buckwheat appears to be successfully recruiting throughout the observation area. In the center of the channel, species observed included non-natives rated as both limited and moderate by the California invasive Plant Council (Cal-IPC) and included stork's bill filaree (*Erodium cicutarium*), short-pod mustard (*Hirschfeldia incana*), milk thistle (*Silybum marianum*), and tocalote (*Centaurea melitensis*). Although overall invasive coverage in this general area has decreased, ornamental plants from nearby landscaping parcels appear to be encroaching onto the easement. Landscaping plants such as ornamental acacia and Peruvian pepper tree (*Schinus mole*) are beginning to establish individuals and populations on site that are now competing with native plant species.

**Recommended Action:** Treatment of annual invasives and removal of the highly invasive Peruvian pepper tree should be prioritized in 2021.

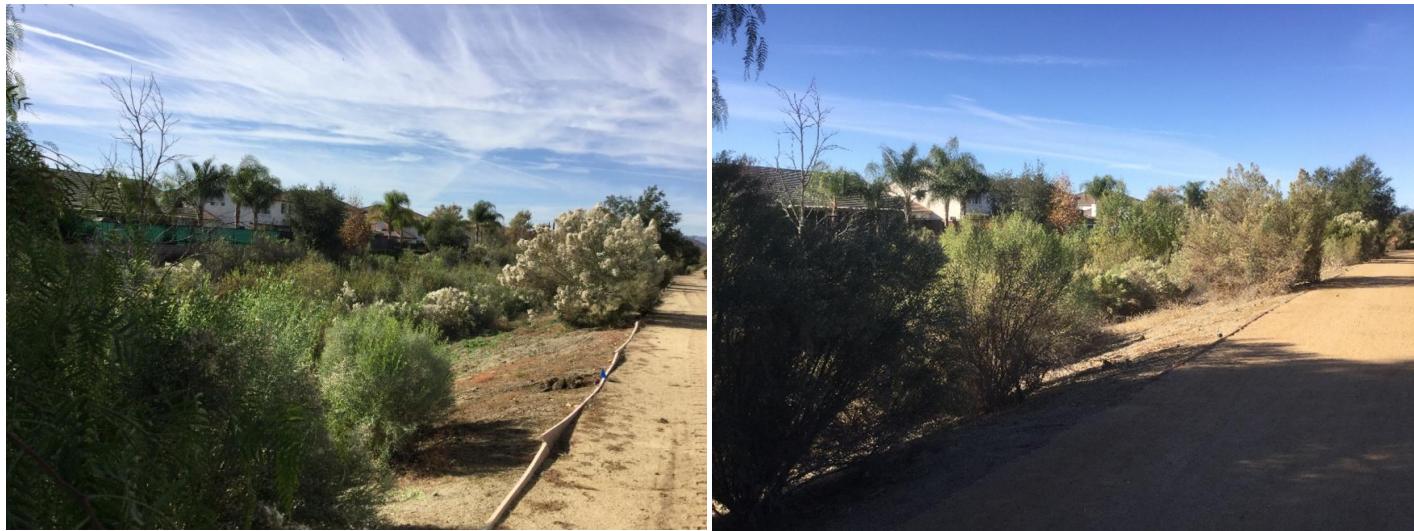
**Photo Point 2** Photos taken on 12/17/19 (left) and on 12/24/20 (right)

**Summary of Conditions:** This photo point is characterized by a similar composition as Photo Point 1 with the exception of coyote bush (*Baccharis pilularis*) in addition to muelfat; however, the density is greater and has increased based on monitoring between 2019 and 2020. In the spaces between native shrubs and trees, limited and moderate-rated invasives observed include stork's bill filaree (*Erodium cicutarium*), short-pod mustard (*Hirschfeldia incana*), and tocalote (*Centaurea melitensis*). Similar to Photo Point 1, despite decline in overall invasive coverage, ornamental plants from nearby landscaping parcels are continuing to escape onto the conservation easement. Landscaping plants such as ornamental acacia and Peruvian pepper tree (*Schinus mole*) are beginning to establish individuals and populations on site that are now competing with native plant species. Site conditions around this photo point remained nearly the same as last year.

**Recommended Action:** Treatment of annual invasives and removal of the highly invasive Peruvian pepper tree should be prioritized in 2021.

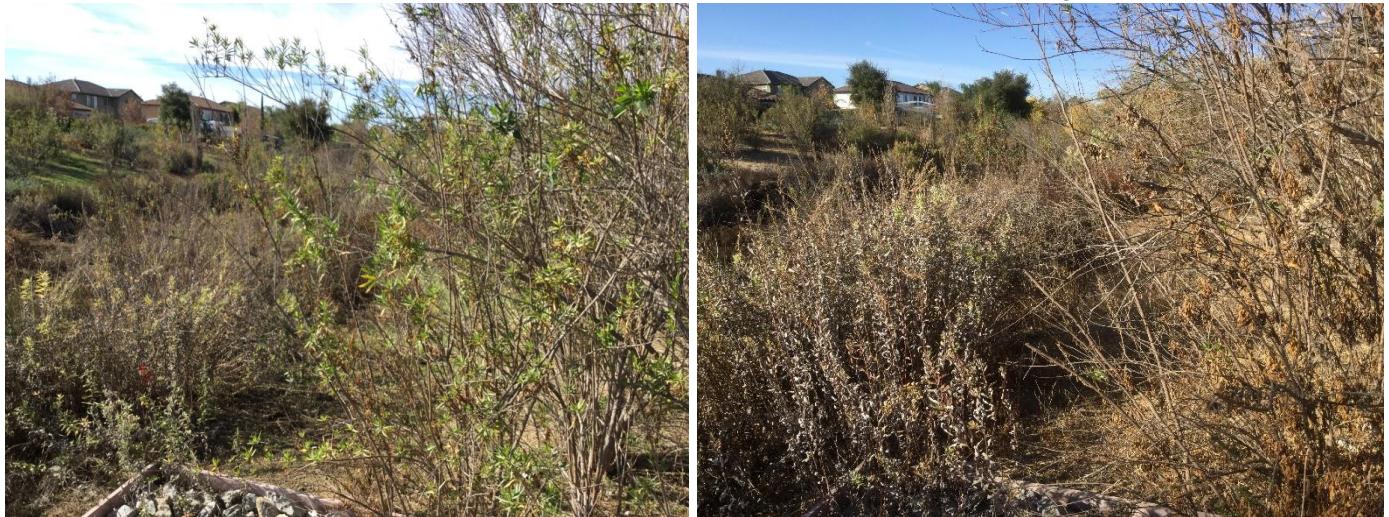
**Photo Point 3:** Photos taken on 12/17/19 (left) and on 12/24/20 (right)

**Summary of Conditions:** This Photo Point is dominated by a moderately dense overstory of mulefat (*Baccharis salicifolia*) and mixed willows (*Salix spp.*), with an understory of mugwort (*Artemisia douglasiana*) and California sagebrush (*Artemisia californica*). Despite additional recruitment of natives observed between 2019 and 2020, invasive annuals including brome (*Bromus sp.*) and common Mediterranean grass (*Shismus barbatus*) were still observed to be germinating on site.

**Recommended Action:** Treatment of invasives during annual monitoring or a separate site visit is recommended in 2021.

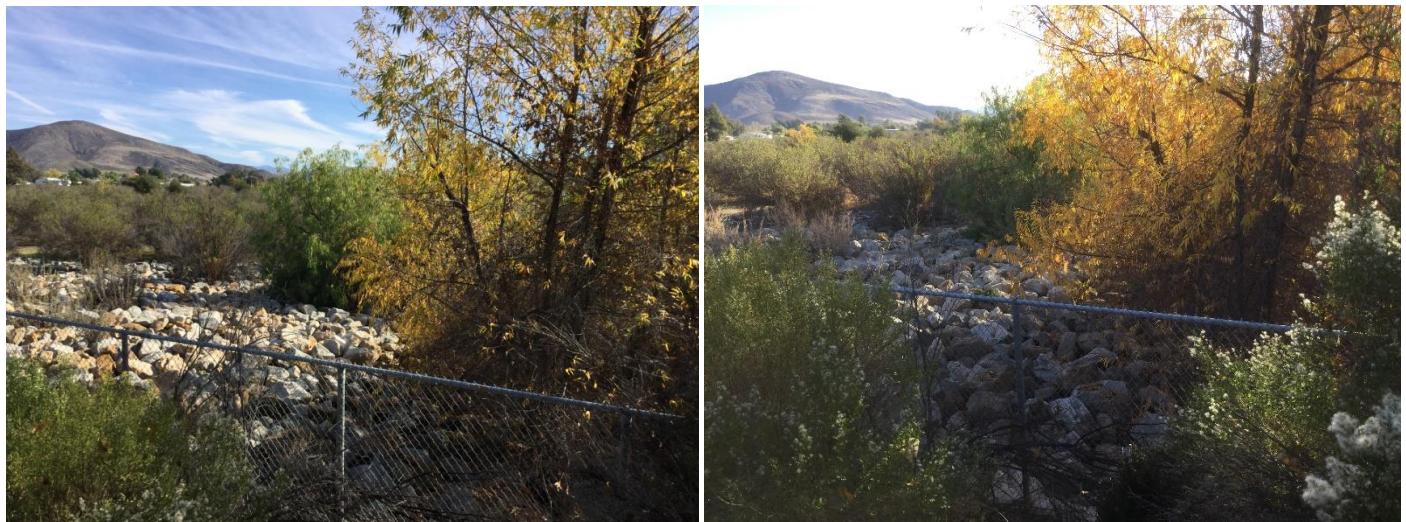
**Photo Point 4:** Photos taken on 12/17/19 (left) and on 12/24/20 (right)

**Summary of Conditions:** This photo point and the areas immediately adjacent (just outside of the easement) are dominated by coyote bush (*Baccharis pilularis*) and mixed willows (*Salix spp.*). Invasives

observed in 2019 have decreased in 2020, possibly due to elevating recruitment of natives. Remaining invasives present on site include tocalote (*Centaurea melitensis*) and stork's bill filaree (*Erodium cicutarium*).

**Recommended Action:** No dire action required in 2021; however, this site should be treated for invasive annual presence as part of a larger effort to control non-natives throughout adjacent photo point areas.

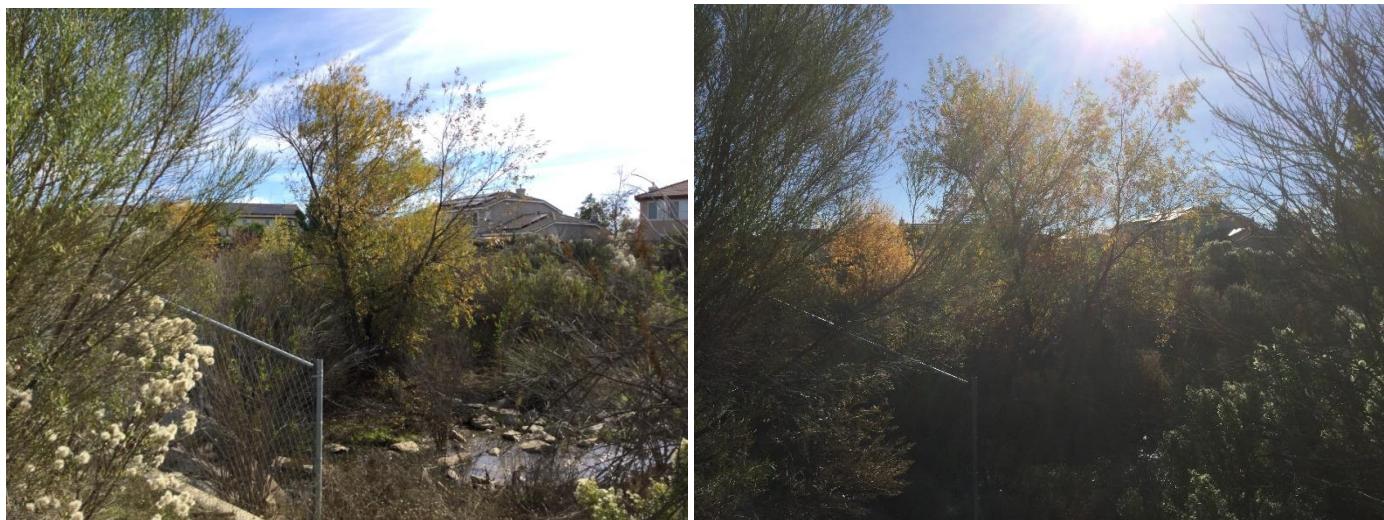
**Photo Point 5:** Photos taken on 12/17/19 (left) and on 12/24/20 (right)

**Summary of Conditions:** Photo Point 4 can be characterized as moderately-dense mixed willow (*Salix spp*) and mulefat (*Baccharis salicifolia*) with invasive grasses including brome (*Bromus sp.*) and common Mediterranean grass (*Shismus barbatus*) observed to be germinating on site but in reduced number (using 2017 photo points as reference). The area around the cement culvert still highly disturbed with continued recruitment and establishment of non-native tocalote (*Centaurea melitensis*). Water is now pooling in the lower section of the site. Area remains in the same general condition as last site visit.

**Recommended Action:** Photo Point 4 ranks relatively high in treatment need due to spreading non-native annuals and should be treated at least in April or May of 2021 when treatments will be most effective.
