TEMECULA CREEK CHANNEL AD 159

REPORT AREA I: LIST OF ALL HABITAT CREATION, RESTORATION, ENHANCEMENT, AND CONSERVATION PROJECT AREAS CURRENTLY BEING MANAGED BY PERMITTEE

REPORT AREA II: DESCRIPTION OF THE HABITAT RESTORATION, ENHANCEMENT, AND CONSERVATION ACTIVITIES PERFORMED WITHIN EACH PROJECT AREA

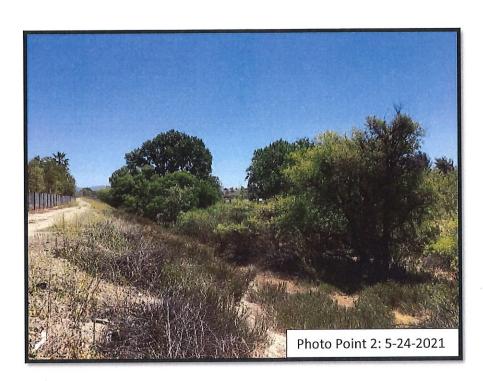
Homeless Point 1: -33.47315° -117.12879°

Monday 5-24-2021: A SAWA Lead Technician inspected Temecula Creek AD 159. Two transients were detected in the same camp near Pechanga Pkwy. (see Homeless Point 1).
